ITTO-ISWA Project PD 286/04 Rev.1 (I)

"Strengthening the Capacity to Promote Efficient Wood Processing Technology in Indonesia"

# IMPLEMENTATION OF IN-HOUSE TRAINING ON WOOD PROCESSING TECHNIQUES

Jakarta, September 2009

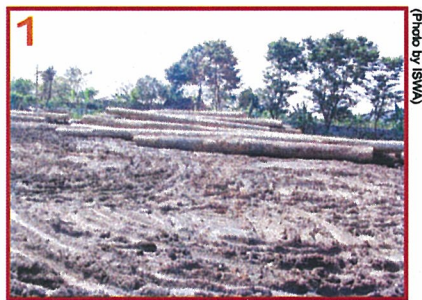
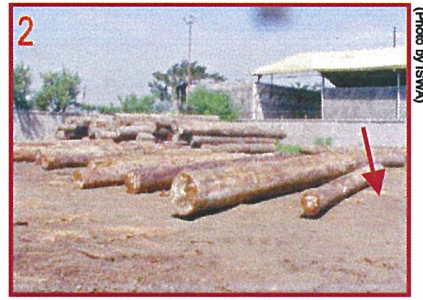
- ✓ Logs were stacked in open area, directly expose to rain and sunlight and in contact with muddy or sandy soil;
- ✓ Figs 1 to 4 illustrate improper handling of logs at a logyard;

Figures 1-2. Logs piled directly on earth

- ✓ Logs must be protected from direct exposure to rain and radiation by applying appropriate cover on top of logs pile;
- ✓ Logs shall not be stacked in direct contact with earth but on top of wooden or concrete tiles;
- ✓ Crack or spilt at log ends must be prevented from propagating by applying plastic S-hook or end-coating;
- ✓ Logs must be washed with water before loading onto carriage to ensure cleanliness of the logs;
- ✓ Logs must be prevented from the attack of pest and disease through fumigation or other treatments as appropriate.

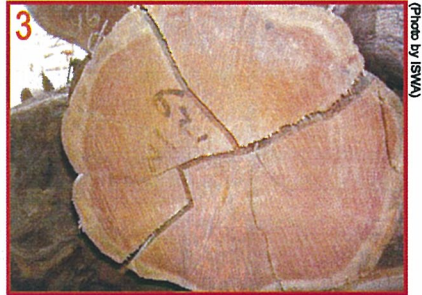
- ✓ Many cracked or split logs were not attended using S-hook or end coating in order to prevent crack propagation.

Figure 3. Logs split without S-hook

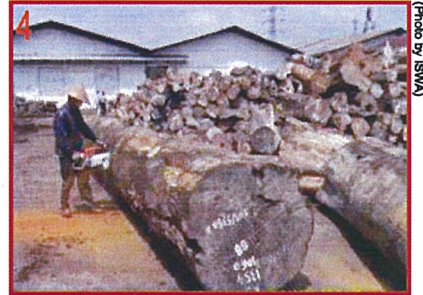
Figure 4. Logs without treatment got rotten

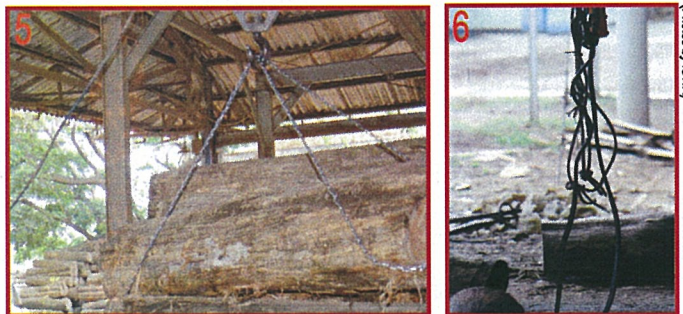
- Most of the cranes used steel cable (sling) or steel chain, some were worn out or damaged;
- Use of worn out or damaged cables is dangerous especially during rainy season when logs get slippery;

Figures 5-6. Log craning using damaged steel chain and steel cable

- Use clamping devices in place of cable or chain;
- In case steel cable is used, routine maintenance and periodic replacement is required.

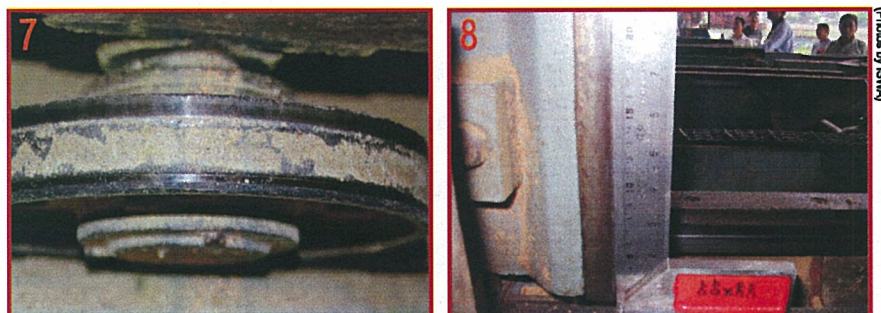
- Carriage wheels were seldom equipped with sawdust scraper which hindered smooth movement of the carriage;
- Log-skid bed was not positioned at the right angle to the knee and fork head was not perpendicular to the band saw giving rise to angled sawing of wood;
- Rails which were not completely straight, or not similar in height, particularly at end-connection parts, or unequal in lateral-space distance resulting in unequal thickness or curving of sawn timber and the presence of sawmark;
- Foundation of band saw was weak causing vibration and defected sawn timber;

Figures 7-8. Wheel covered by sawdust (7); log skid bed and kneenot not perpendicular (8)

- Carriage wheels should be always equipped with scrapper particularly at the side facing band saw;
- Ensure that the position of log skid bed knee with fork head, and band saw is correct before starting sawing operation;
- Make sure that rails are straight, similar in height particularly at the end connection parts, and equal in lateral distance;
- Routine maintenance of paper brake as well as pulling cable is essential;
- Placing of a mirror behind the log carriage is helpful for sawing operator to observe and examine log condition and to determine the right sawing strategy;
- To optimize wood recovery, the observation mirror is better combined with use of laser ray.

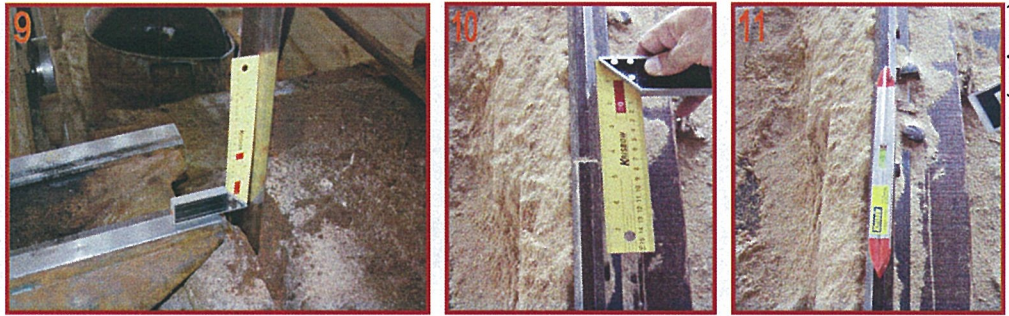
- Paper brake and pulling cable (cable sling) which were seldom replaced, hindered the log-carriage movement, and hampered sawing operation;
- Log carriage was seldom equipped with mirror to help operator observe the condition of a log to saw and use of laser ray is infrequent during the wood sawing;

Figures 9-11. Fork head and band saw not perpendicular (9); rails not straight (10); rails not leveled (11)

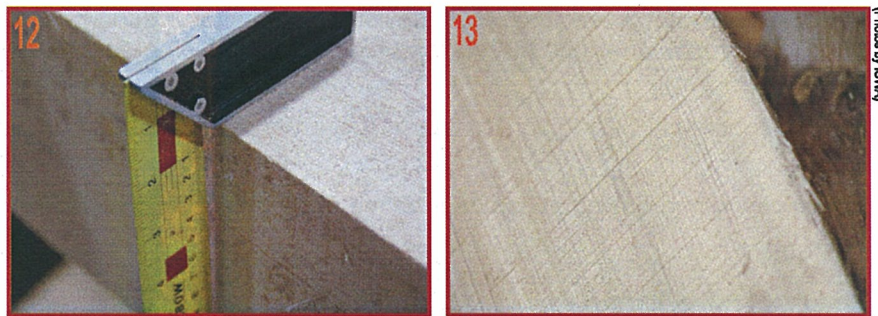
- When a mirror was installed, most operators of sawing seldom paid attention to the mirror and instead performed sawing using instinct or feeling.

Figures 12-13. Angled end sawn timber (12); sawmark on sawn timber (13)

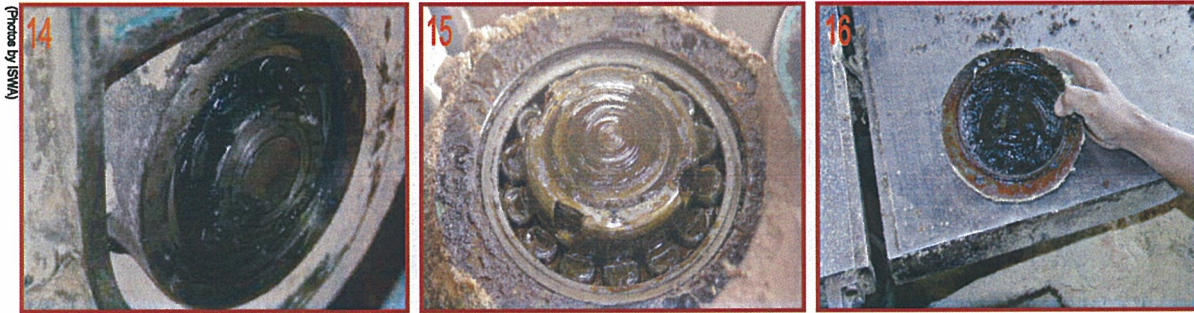
- At some mills, the base foundation of break-down machine, pony device, and saw was weak by using wooden support and resulted in vibrating and shaking machine and consequently, defected sawn wood;
- Improper greasing of bearing in terms of timing, application of as well as quality of grease caused disturbance to the rotation of band wheels and band saw and resulted in saw mark as well as irregular dimension of sawn wood.

Figures 14-16. Improper greasing of band wheel bearing: late greasing (14), incorrect application of grease (15) and use of low speed grease (16)

- The foundation for breakdown machine, pony device, and saw table should be strong and firm enough to bear the load weight, thereby preventing the position of machine and other device from moving;
- The bearing system should be regularly greased using the right quality of grease that is properly applied;
- Use a high speed type of grease that can bear temperature up to 260 °C or above.

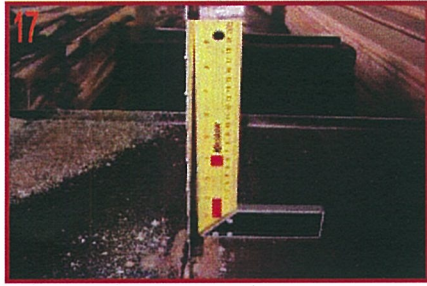
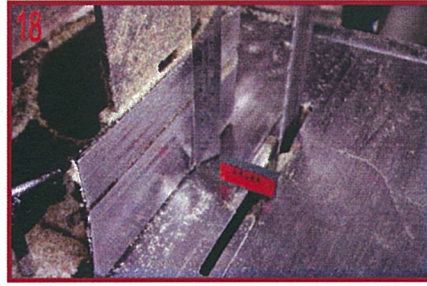
Position of band saw, table, and stopper was not at the right angle and resulted in angled sawing despite the right type of band saw used.

Figures 17-18. Not perpendicular positions of band saw and table (17); table and stopper (18)

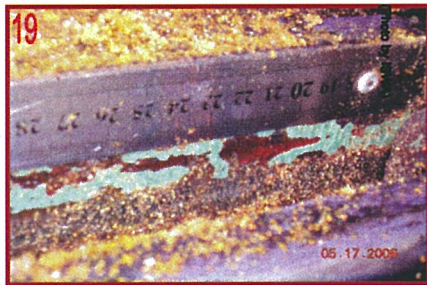
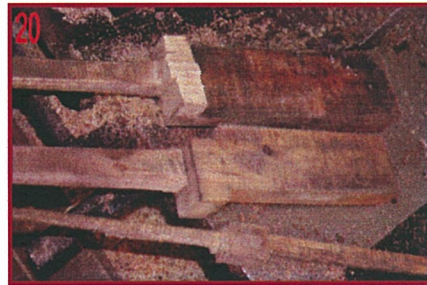
- The scrapper for sawdust at the band wheels already damaged and caused the accumulation of sawdust on the surface of the wheels and further unstable rotation of the band saw;
- The marks on the measuring device for wood thickness and width on the table saw (standard from the factory) were mostly damaged, unclear, or faded away;
- The scratching and making holes on the table to measure width/thickness of wood damaged the table itself.

Figures 19-20. Damaged measuring device (19), and wooden device as replacement (20)

- It is necessary to install scrapper on the upper and lower band wheels using hardwood in order to avoid damaging of the wheel surface (see Figures 21-22);
- Install a standard measuring device (ruler) at the upright side of sawing table in order to be easily observed and give accurate results;
- If a wooden manual measurement is used, make sure that it is made of hardwood with accurate scale.

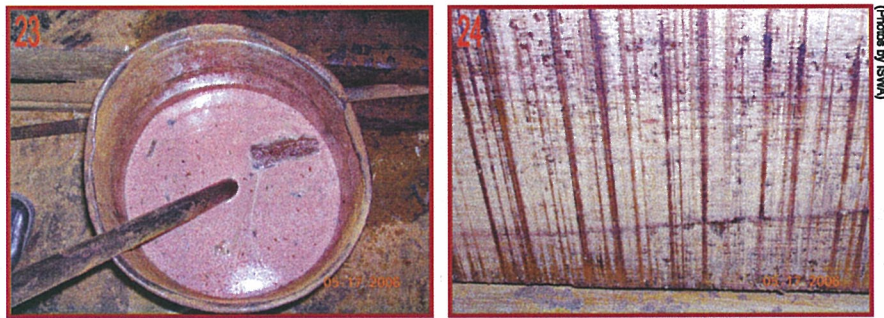
- The cooling of saw used residue of solar/diesel fuel or solar added with detergent, without considering what wood species to be sawn;
- The use of solar residue as a cooling medium left the sawn wood with dirty marks and caused problem in painting and coating process;
- Heated band saw inevitably expanded thereby becoming sandwiched between sawn wood and obstructed sawing work.

Figures 23-24. Use of diesel fuel residue and detergent as coolant (23); and the resulting sawn timber (24)

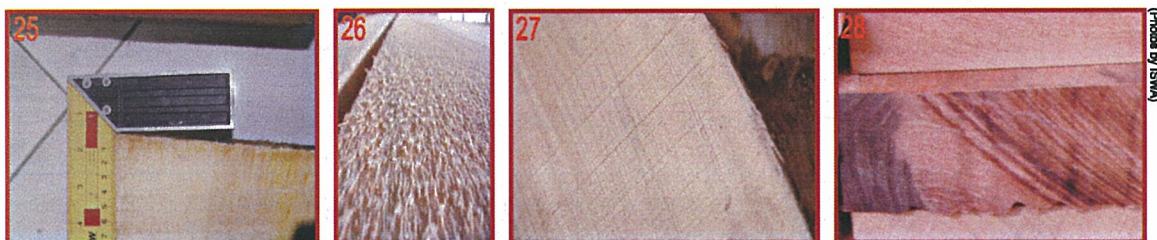
Sawn timber defects resulting from sawing frequently observed at the mills were: sawn timber was not right-angled due to the improper position of band saw and saw table, band saw and stopper, and log trimming not at the right angle as well; fuzzy or hairy surface sawn timber due to blunt saw teeth; saw marks due to the width of sawing teeth, or right and left openings of sawing teeth not equal, or due to shaking band saw; saw burn caused by the sawing teeth sandwiched between wood being sawn (see Figs. 25-28).

Figures 25-28. Angled sawn timber (25); fuzzy surface (26); sawmark (27); and saw burn (28)

- To avoid saw burn, the sawing teeth should not be sandwiched between the wood being sawn;
- To avoid yielded sawn wood full of sawdust, the size of gullet should not be too small.

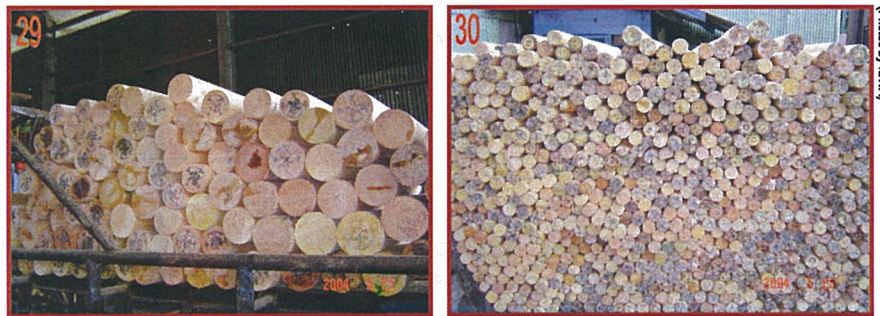
The weaknesses encountered in rotary slicing machine were, among others,; the bar shaft where the chuck is placed, shacked severely, rendering the wood grain not straight, and resulted in unequal thickness between left side and right side of the veneer produced; the chuck used was already worn out and damaged, thereby lessening its gripping capability; in addition, the chuck as used provided only one size of log diameter (16-20 cm), gave rise to large diameter peeling residual (core) although many mills have utilized the core in finger jointing for laminated stick or bare core.

Figures 29-30. Core diameter of 16-20 cm (29); of 5-7 cm (30)

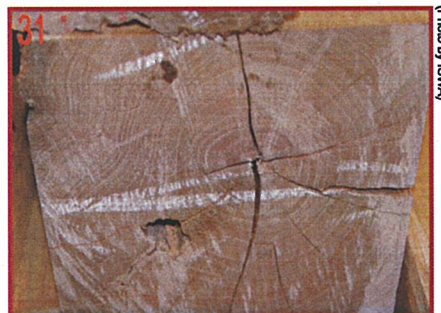
Use of log squares caused break off of wood slice at the end parts and one side not right-angled.

Figure 31. End split of log squares

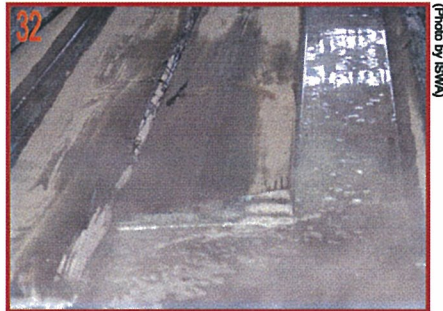
- The boiling of log squares was not properly done;
- The logs were not completely submerged/soaked in the boiling water causing uneven hardness of wood.

Figure 32. Improper boiling of log squares

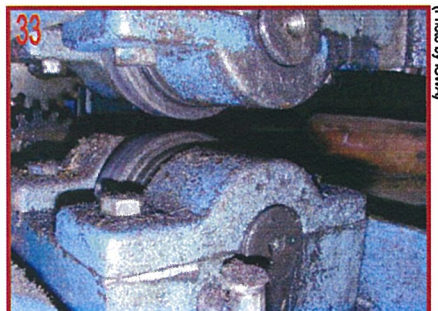
- Many benching tables were rough and damaged, positioned not parallel with the stretching roller and effected smoothness of leveling and stretching work results;
- Stretching roller was usually worn out, upper and lower wheels already smooth/not rough any longer on its surface;
- Many mills did not perform proper straightening, tensioning and leveling.

Figure 33. Worn out stretching roller.

- Replace or lathe the surface of sharpening wheel such that the diameter of the center part of the wheel equals to 1 mm or in accordance with factory standard;
- The contact and touching point between two wheels must form one point (about 1 mm in diameter); otherwise the band saw will sustain greater pressure, when the point have large diameter;
- When the position of illumination lamp is exactly over the table, this can cause difficulty to the technician to examine whether the band saw is leveled out. Therefore, the lamp must be placed in the opposite direction to that of the technician, thereby effectively assisting in examining the levelness of band saw.

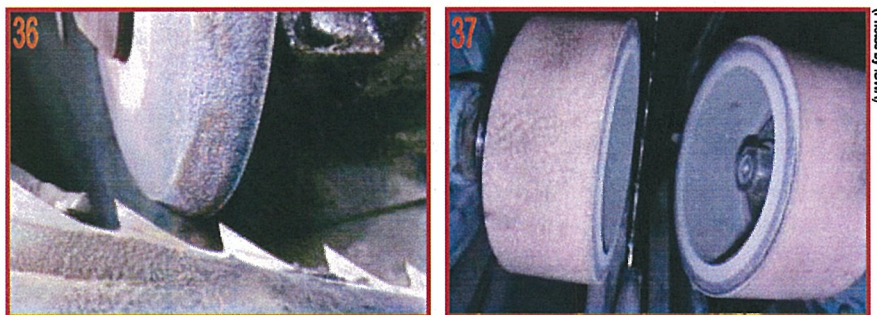
- White color indicates that the surface of double-side sharpener does not touch the saw teeth, while the part that touches it reveals black color;
- This situation renders the tallest saw teeth easily broken off or ruptured, during operation the band saw vibrates causing the size of sawn products not corresponds to the desired size, and saw mark appears on the surface of sawn timber.

Figures 36-37. Scratchy and craggy grinding stone (36) and incorrect setting of double-side sharpener (37)

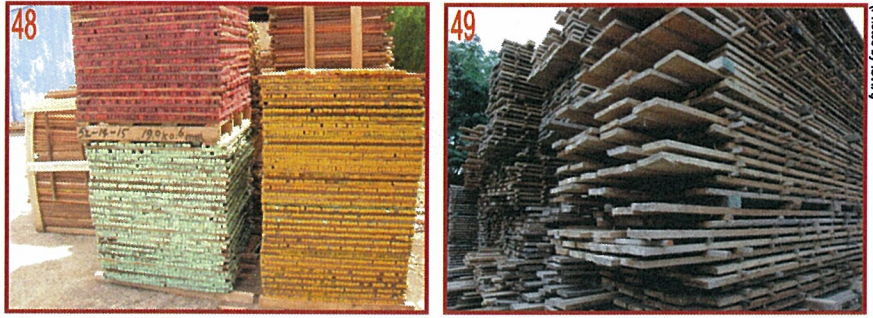
Figures 48-49. Sticks are the same as the wood to be dried (48); random stacking (49)

- The distance between wood sticks must be suited with the length and thickness of wood under conditioning;
- Dimension of sticks must be similar to avoid wood from bowing, curving, etc.;
- Do not use wood sticks the same as the wood to be conditioned;
- Make sure that the size of pallet used is suitable with that of the wood stuffs to be handled;

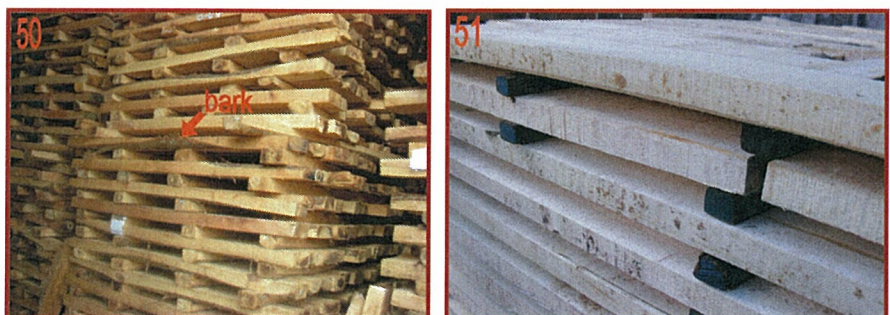
Figures 50-51. Conditioned timbers contain bark (50); covered by dust (51)

- The size of and distance between sticks must be suited with the thickness of woods to be dried.

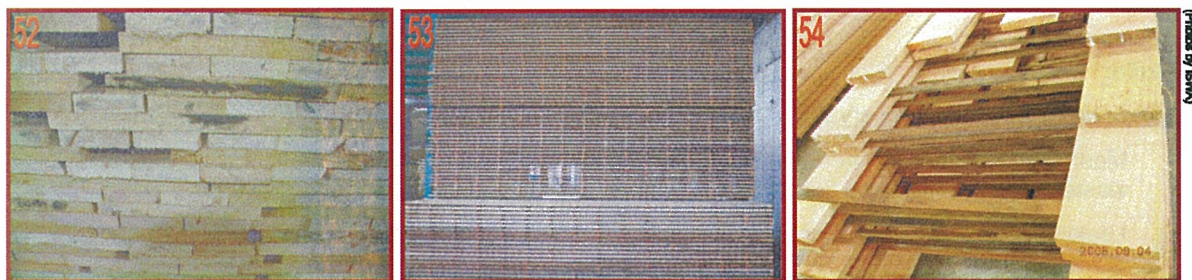
Figure 52-54. Conditioned timbers stacked without air circulation (52); Conditioned timbers properly stacked (53-54)

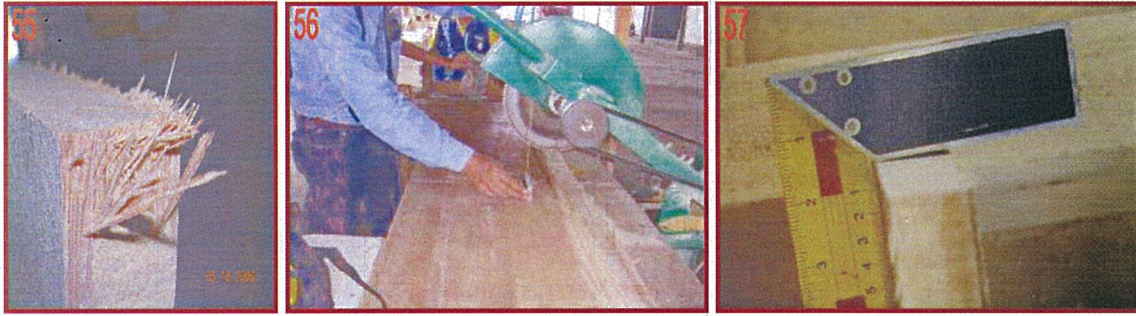
Figures 55-57. Improper installment of cross-cut machine causing fuzzy product (55); table and knife not perpendicular (56); causing angled cut panel (57).

- The cross-cut machines (circular, arm, and jumping saw) must be properly and accurately installed, thereby securing their stable position;
- The knife blade must always be in sharp condition;
- Position of knife, table, and stopper must be at the right angle with each other;
- The round saw plate must be even, height and sharpness of knife blade must correspond to the pre-specified technical standard.

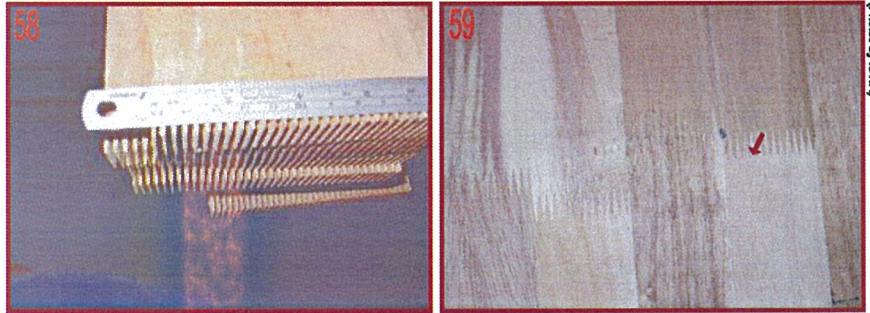
Figures 58-59. Tongue and groove joints not uniform in height (58); and occurrence of pinhole at the joints (59).

The knife blade should have sharpness, height, width, and distance in accordance with the pre-specified standards in order to ensure quality groove and tongue and avoid the presence of pinhole that affects the strength of joint.

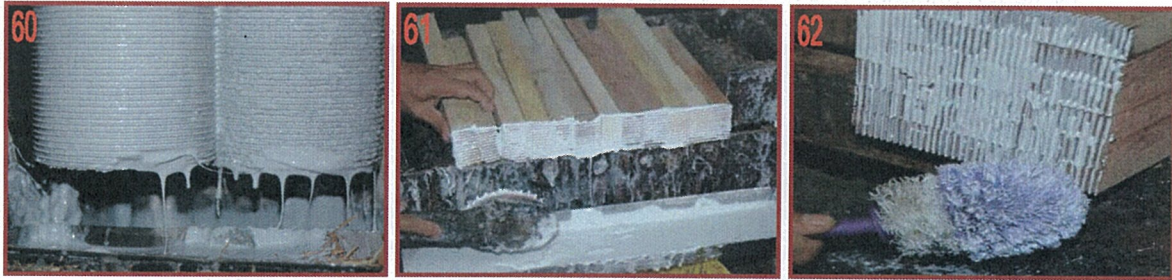
Figures 60-62. Damaged cylinder of glue spreader (60); horizontally positioned panel for gluing (61); using unsuitable brush for gluing (62).

- Apply glue to only 2/3 of tongue surface;
- Use a suitable form of brush with plastic hair to facilitate evenly and thinly spread of glue.

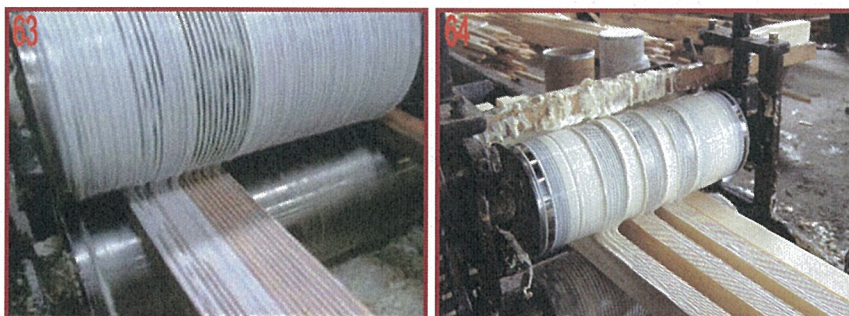
Figures 63-64. Roller glue-spreader partly damaged (63); in good condition (64).

- Ensure that the size of panels should not differ from each other;
- The glue spreader must always be clean, the hole for glue spreading must not be damaged and glue mixing should be appropriate.

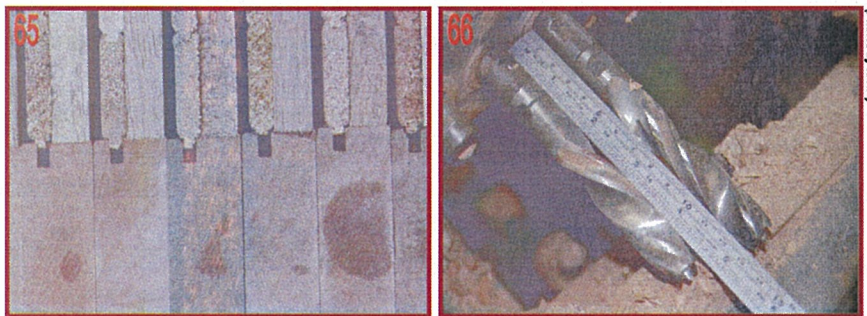
Figures 65-66. Result of inappropriate size of male and female knives (65); drilling heads with differing length (66).

- Examine accuracy of a product using standard device such as tongue and groove-shaping metal and micrometer.

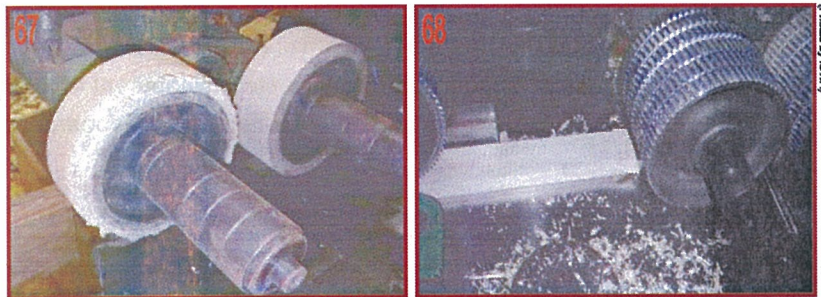
Figures 67-68. Rubber roller (67); and iron roller (68) having width differs from the panel.

- Rubber rollers must be kept in good condition, and their hardness meets the required standards to stand with high speed rotation of machine;
- Do not use rubber and iron rollers, simultaneously;
- If simultaneous use is required, iron roller should be placed at the front and rubber roller at the rear;
- The size of roller must correspond to the size of wood to be planed.

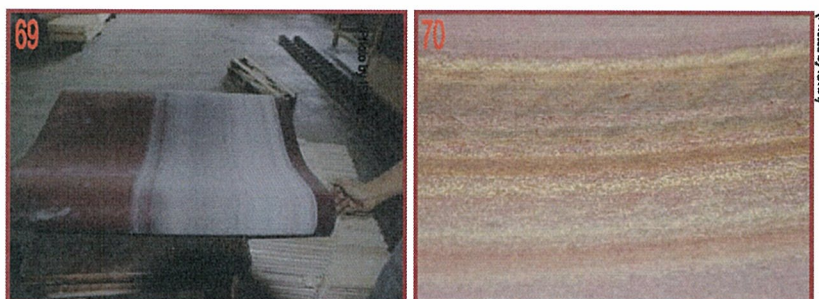
Figures 69-70. Inappropriate use of sanding paper (69); and sanding paper is covered by glue (70).

- In order that all the surface of sanding paper is used or performs the sanding, the panel is put into the sanding-paper machine at an angle or diagonally;
- Avoid the panel or lamella being stuck by the glue; if so, the panel/lamella should be cleaned or cleared of the sticking glue after the laminating process;
- Make sure that glue is already dried/hardened so that during the sanding the glue will not thicken or accumulate, thereby prolonging the service life of sanding paper.

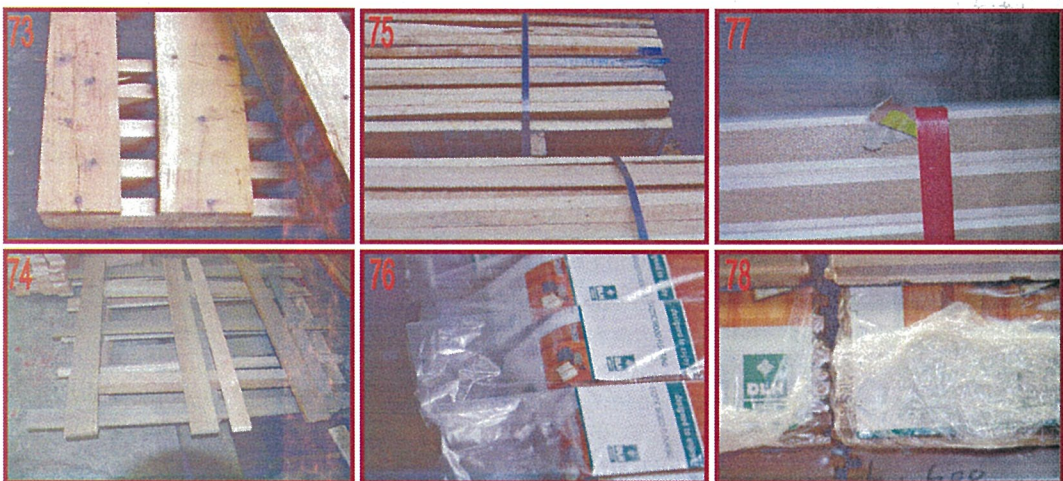
Figures 73-78. Samples of inappropriate packaging.

- In designing and constructing package, performance, strength and cost of material should be used as the primary criteria.
