Forest Products Research and Development Institute  
ITTO Project PD 35/99 Rev. 4 (I)  
FINAL TECHNICAL REPORT

**Performance Evaluation of Export Wood Furniture  
in Relation to Strength and End-Use Applications  
Using Established Test Standards**

Los Baños, Laguna, Philippines  
December 2004

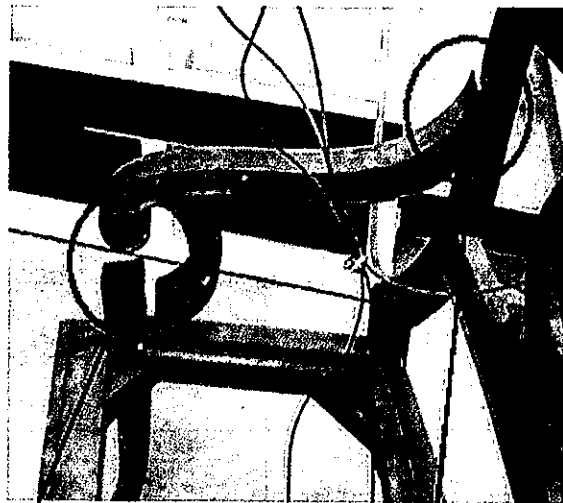
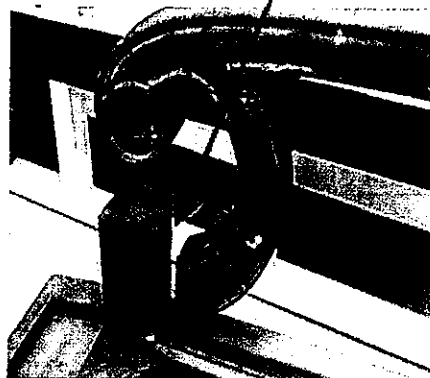
<b>D. Inspection and Assessment Results</b>	
a. fracture or cracking of any member, component or joint, including seat suspensions, castors, and structural shells.	Breakage and detached armrest from front right leg and back leg. Severe damage occurred during drop test
b. loosening, shown to be permanent by hand pressure applied to suitable members, or joints intended to be rigid.	No loosening occurred prior to drop test
c. loosening of the under frame or base inserts moulded into a structural shell relative to the shell surface, shown to be permanent by hand pressure applied on the under frame or base.	No loosening of underframe
d. free movement in the back, arms, legs or other components of the article greater than that noted in the initial inspection.	No free movements in sample parts prior to drop test

**Damages that occurred at the armrest during drop test**

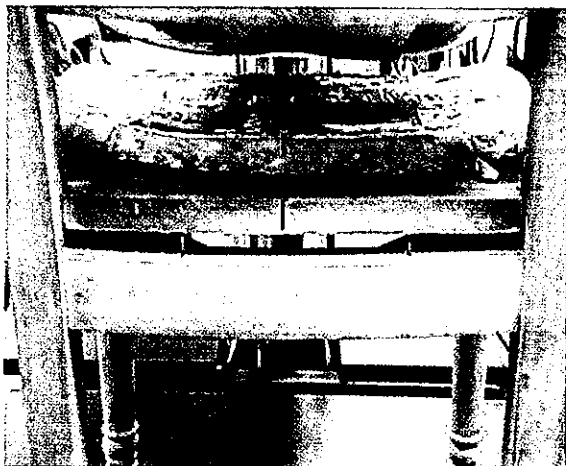
<b>D. Inspection and Assessment Results</b>	
a. fracture or cracking of any member, component or joint, including seat suspensions, castors, and structural shells.	Sample failed during seat and back fatigue test
b. loosening, shown to be permanent by hand pressure applied to suitable members, or joints intended to be rigid.	Severe loosening of back legs and side rail joint connection. Laminated seat detached at the back portion of chair after 875 cycles during the combined seat and back fatigue test
c. loosening of the under frame or base inserts moulded into a structural shell relative to the shell surface, shown to be permanent by hand pressure applied on the under frame or base.	Sample failed during seat and back fatigue test

**Damages that occurred during combined seat and back fatigue test**

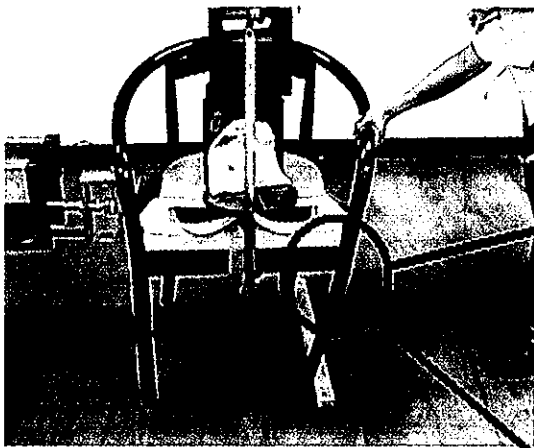
**Loosening of seat frame joint and splitting of rattan pole during leg sideways static load test**

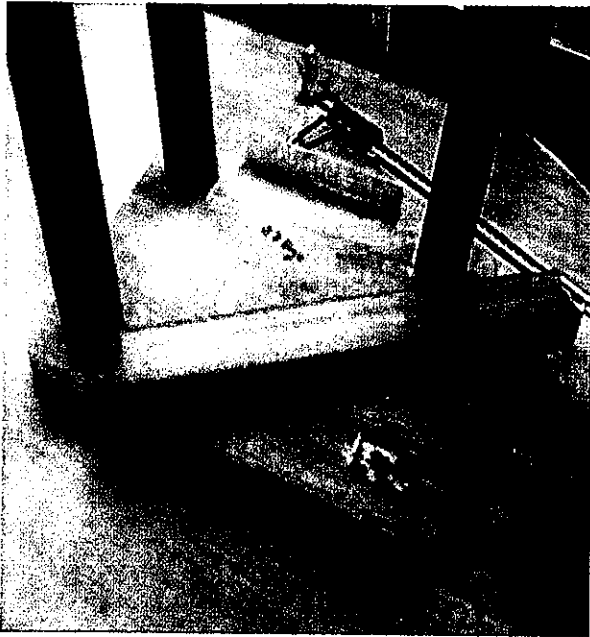
**Damage evaluation after back static load test**

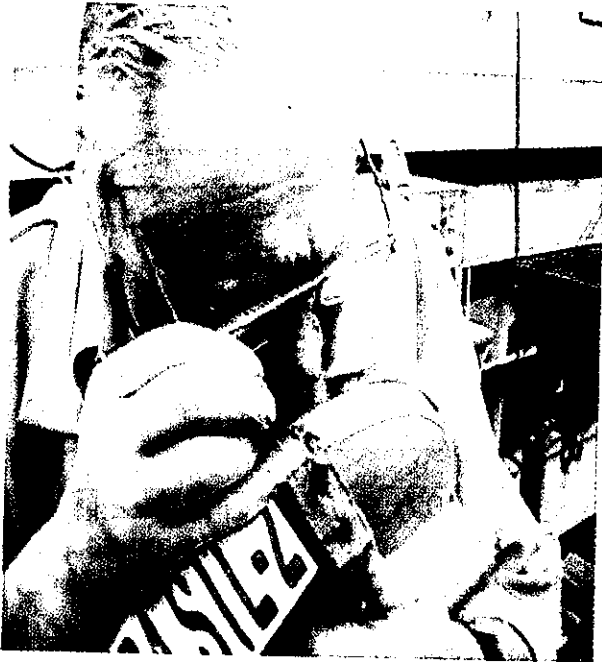
**Damage evaluation after back static load test**

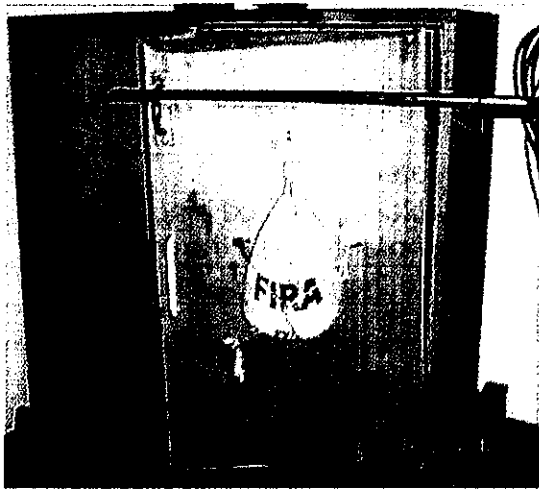
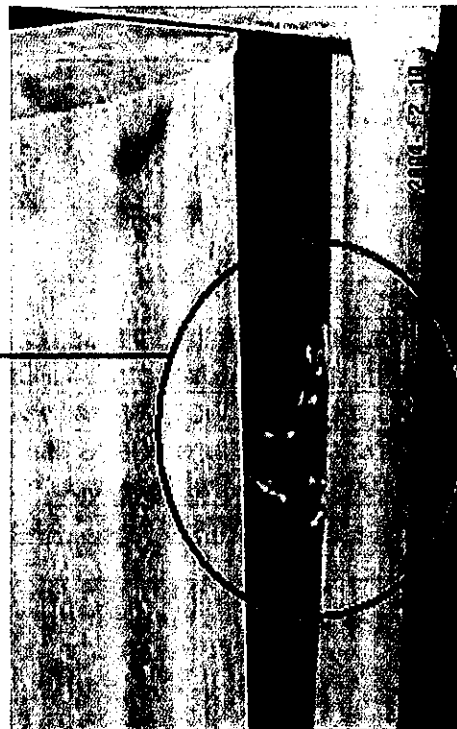
The pivoted cabinet doors failed the durability test. Failure occurred at the door hinges during load application. Except for the metal hinges, the integrity of the wood portion was intact. For drawers of cabinet, the samples passed the horizontal load movements slam-shut and open. For tables, the sample tilted in stability under vertical load. The tilting was primarily due to the long overhang of the table top from the posts or legs. The tilting of the table did not affect its serviceability.

**The metal concealed hinges were deformed that resulted in the loosening of the cabinet doors after 20,810 cycles**

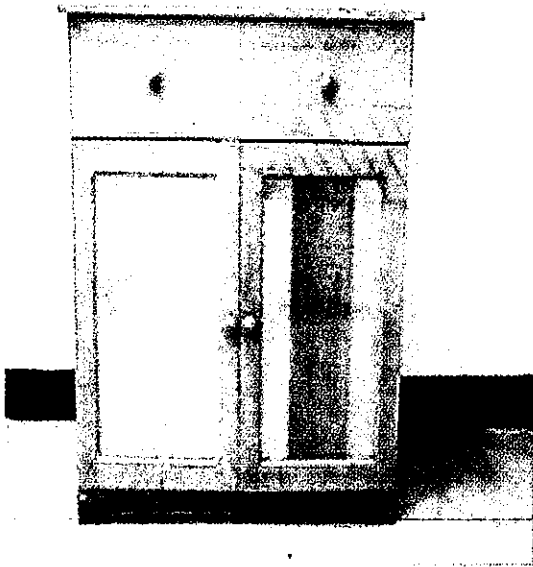
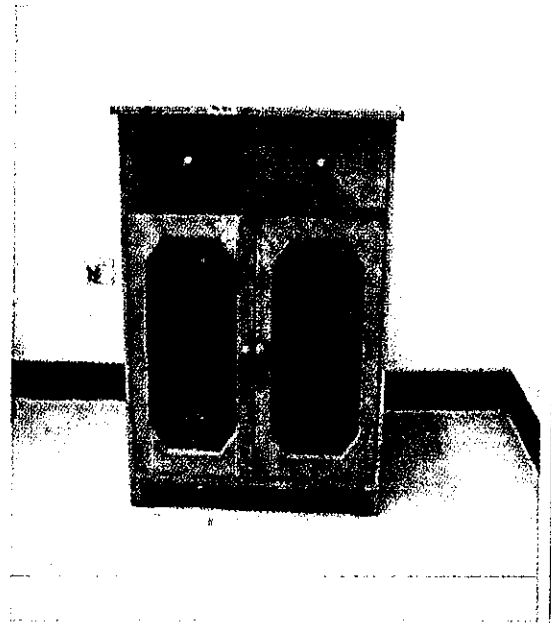
**Metal concealed hinges were deformed during the application of vertical load of 25 kgs suspended 100 mm from the edge of the door**
