Forest Products Research and Development Institute  
ITTO Project PD 35/99 Rev. 4 (I)  
FINAL TECHNICAL REPORT

**Performance Evaluation of Export Wood Furniture  
in Relation to Strength and End-Use Applications  
Using Established Test Standards**

Los Baños, Laguna, Philippines  
December 2004

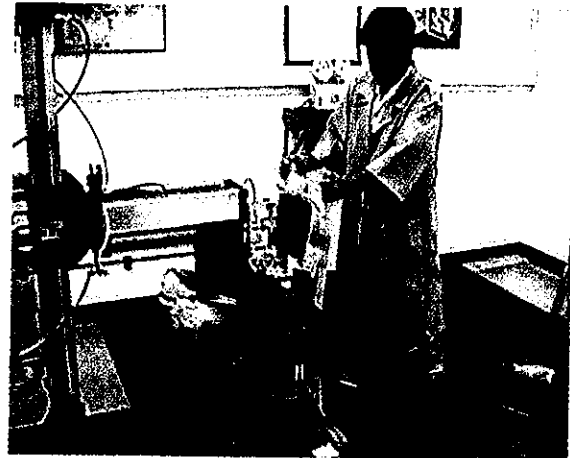
**Back static load test**
