Forest Products Research and Development Institute  
ITTO Project PD 35/99 Rev. 4 (I)  
FINAL TECHNICAL REPORT

**Performance Evaluation of Export Wood Furniture  
in Relation to Strength and End-Use Applications  
Using Established Test Standards**

Los Baños, Laguna, Philippines  
December 2004

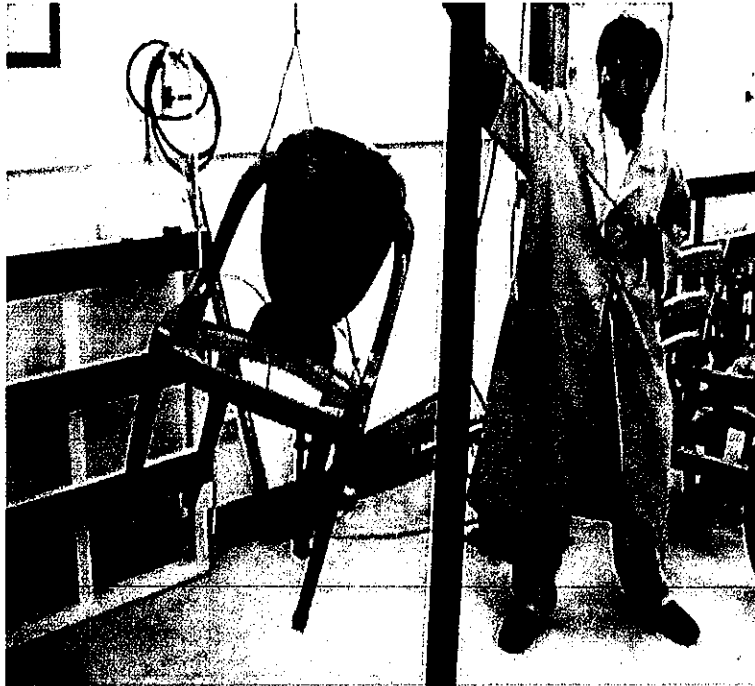
**Drop test**

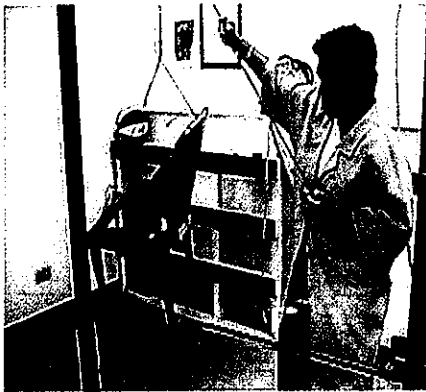
<b>D. Inspection and Assessment Results</b>	
a. fracture or cracking of any member, component or joint, including seat suspensions, castors, and structural shells.	Fracture of left back leg during drop test. Failure of sample at this stage
b. loosening, shown to be permanent by hand pressure applied to suitable members, or joints intended to be rigid.	No loosening of joints and members prior to drop test
c. loosening of the under frame or base inserts moulded into a structural shell relative to the shell surface, shown to be permanent by hand pressure applied on the under frame or base.	No loosening of underframe prior to drop test
d. free movement in the back, arms, legs or other components of the article greater than that noted in the initial inspection.	No free movements of components noted prior to drop test

**Breakage of left back  
leg during drop test**

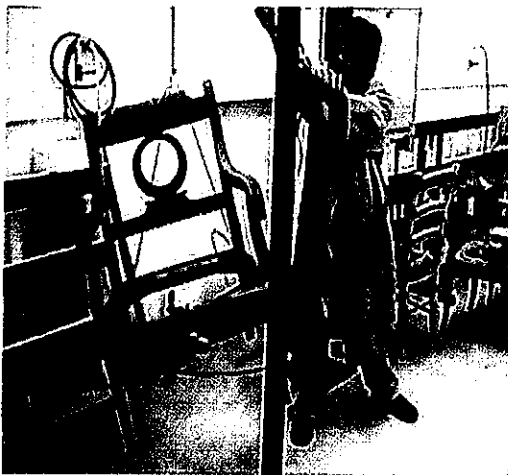
**Drop test**

<b>D. Inspection and Assessment Results</b>	
a. fracture or cracking of any member, component or joint, including seat suspensions, castors, and structural shells.	Breakage and detached armrest from front right leg and back leg. Severe damage occurred during drop test
b. loosening, shown to be permanent by hand pressure applied to suitable members, or joints intended to be rigid.	No loosening occurred prior to drop test
c. loosening of the under frame or base inserts moulded into a structural shell relative to the shell surface, shown to be permanent by hand pressure applied on the under frame or base.	No loosening of underframe
d. free movement in the back, arms, legs or other components of the article greater than that noted in the initial inspection.	No free movements in sample parts prior to drop test

<b>Remarks:</b>
1. The chair was tested using level 3 of the Standards (Furniture – Chairs and Stools – Determination of Strength and Durability)
2. Moisture content was determined using moisture meter
3. Seat and back fatigue test were done simultaneously using 50,000 cycles under test level 3 of the standards
4. Damage occurred during the 7 <sup>th</sup> drop cycle of the drop test
5. The test results presented in this report relate only to the object/sample tested
- Nothing follows -

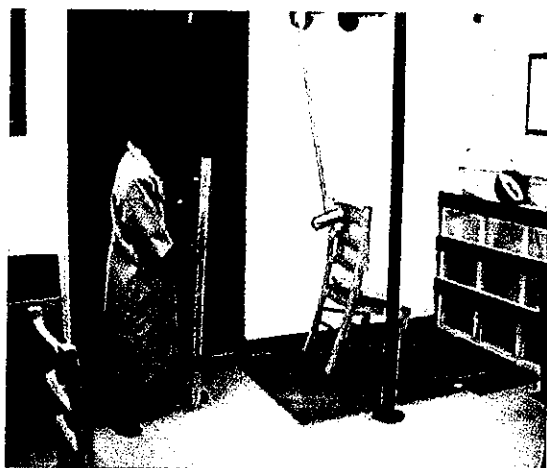
**Back impact test**

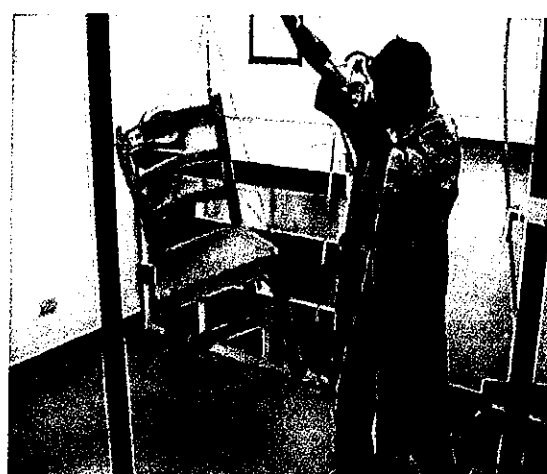
**Drop test**

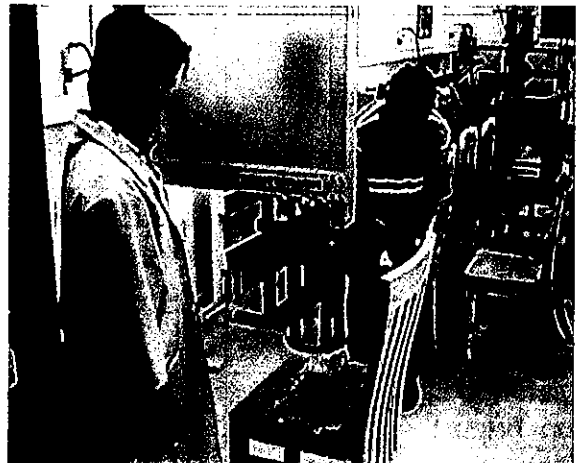
**Seat impact test**

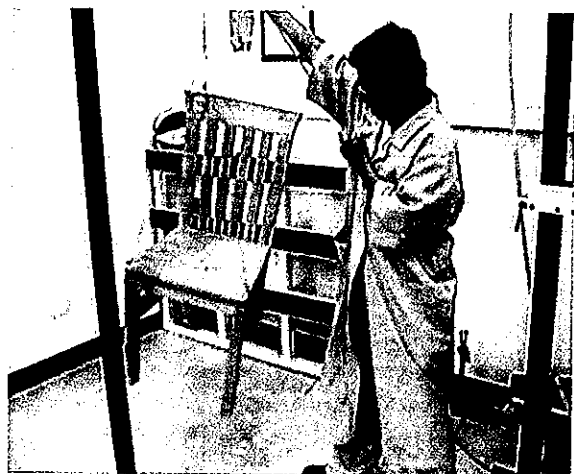
**Drop test**

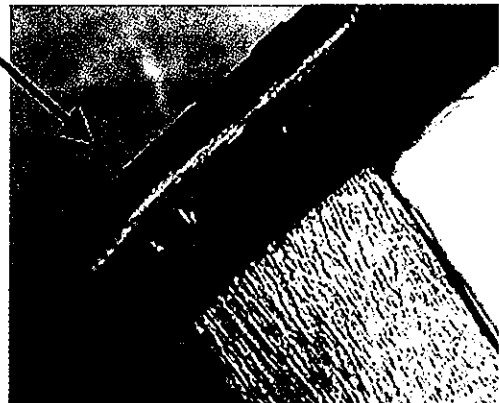
<b>Remarks:</b>
1. Sample was tested using level 3 of the Standards (Furniture – Chairs and Stools – Determination of Strength and Durability)
2. Deformation and loosening of seat frame joint at the leftside front leg and splitting of rattan pole during the application of the load
3. Seat and back fatigue tests were done simultaneously using 50,000 cycles
4. The other tests were not performed after failure occurred during leg sideways static load test
5. The test results presented in this report relate only to the object/sample tested
- Nothing follows -

**Loosening of seat frame joint and splitting of rattan pole during leg sideways static load test**

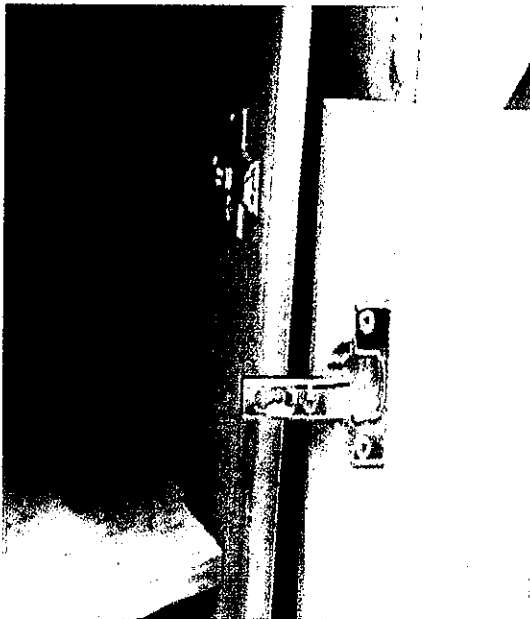
**Metal concealed hinges were deformed during the application of vertical load of 25 kgs suspended 100 mm from the edge of the door**

For pivoted doors of cabinet, the doors failed in durability test. The metal concealed hinges loosened after 20,810 cycles. It requires 40,000 cycles to pass the standards. The cabinet doors also failed in vertical load test. The metal concealed hinges were twisted when a weight of 25 kg suspended 100 mm from the edge of the door was applied.

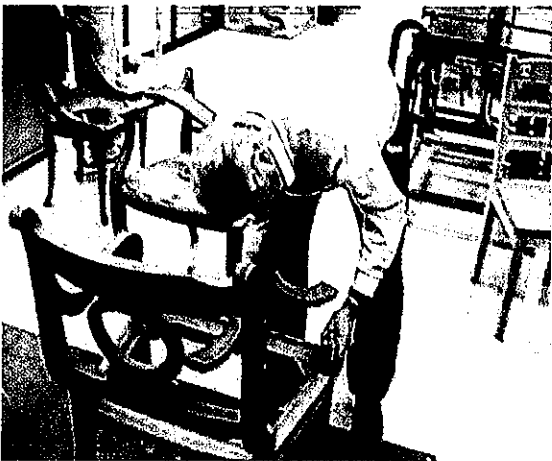
**The project's International Consultant, Engr. William Gulliver assessing damages that occurred during testing and conferring with Engr. Arnaldo P. Mosteiro, the National Expert on testing activities**
